**RAPPORT DES ACTIVITÉS DE VÉRIFICATION DU PROJET DE CRÉDITS
COMPENSATOIRES VISANT LA DESTRUCTION DU CH₄ AU LES DE GRANBY
POUR LA PÉRIODE DU 15 JUILLET 2021 AU 31 MARS 2022**

TERREAU BIOGAZ S.E.C.

ENVIRO-ACCÈS INC.

24 août 2022

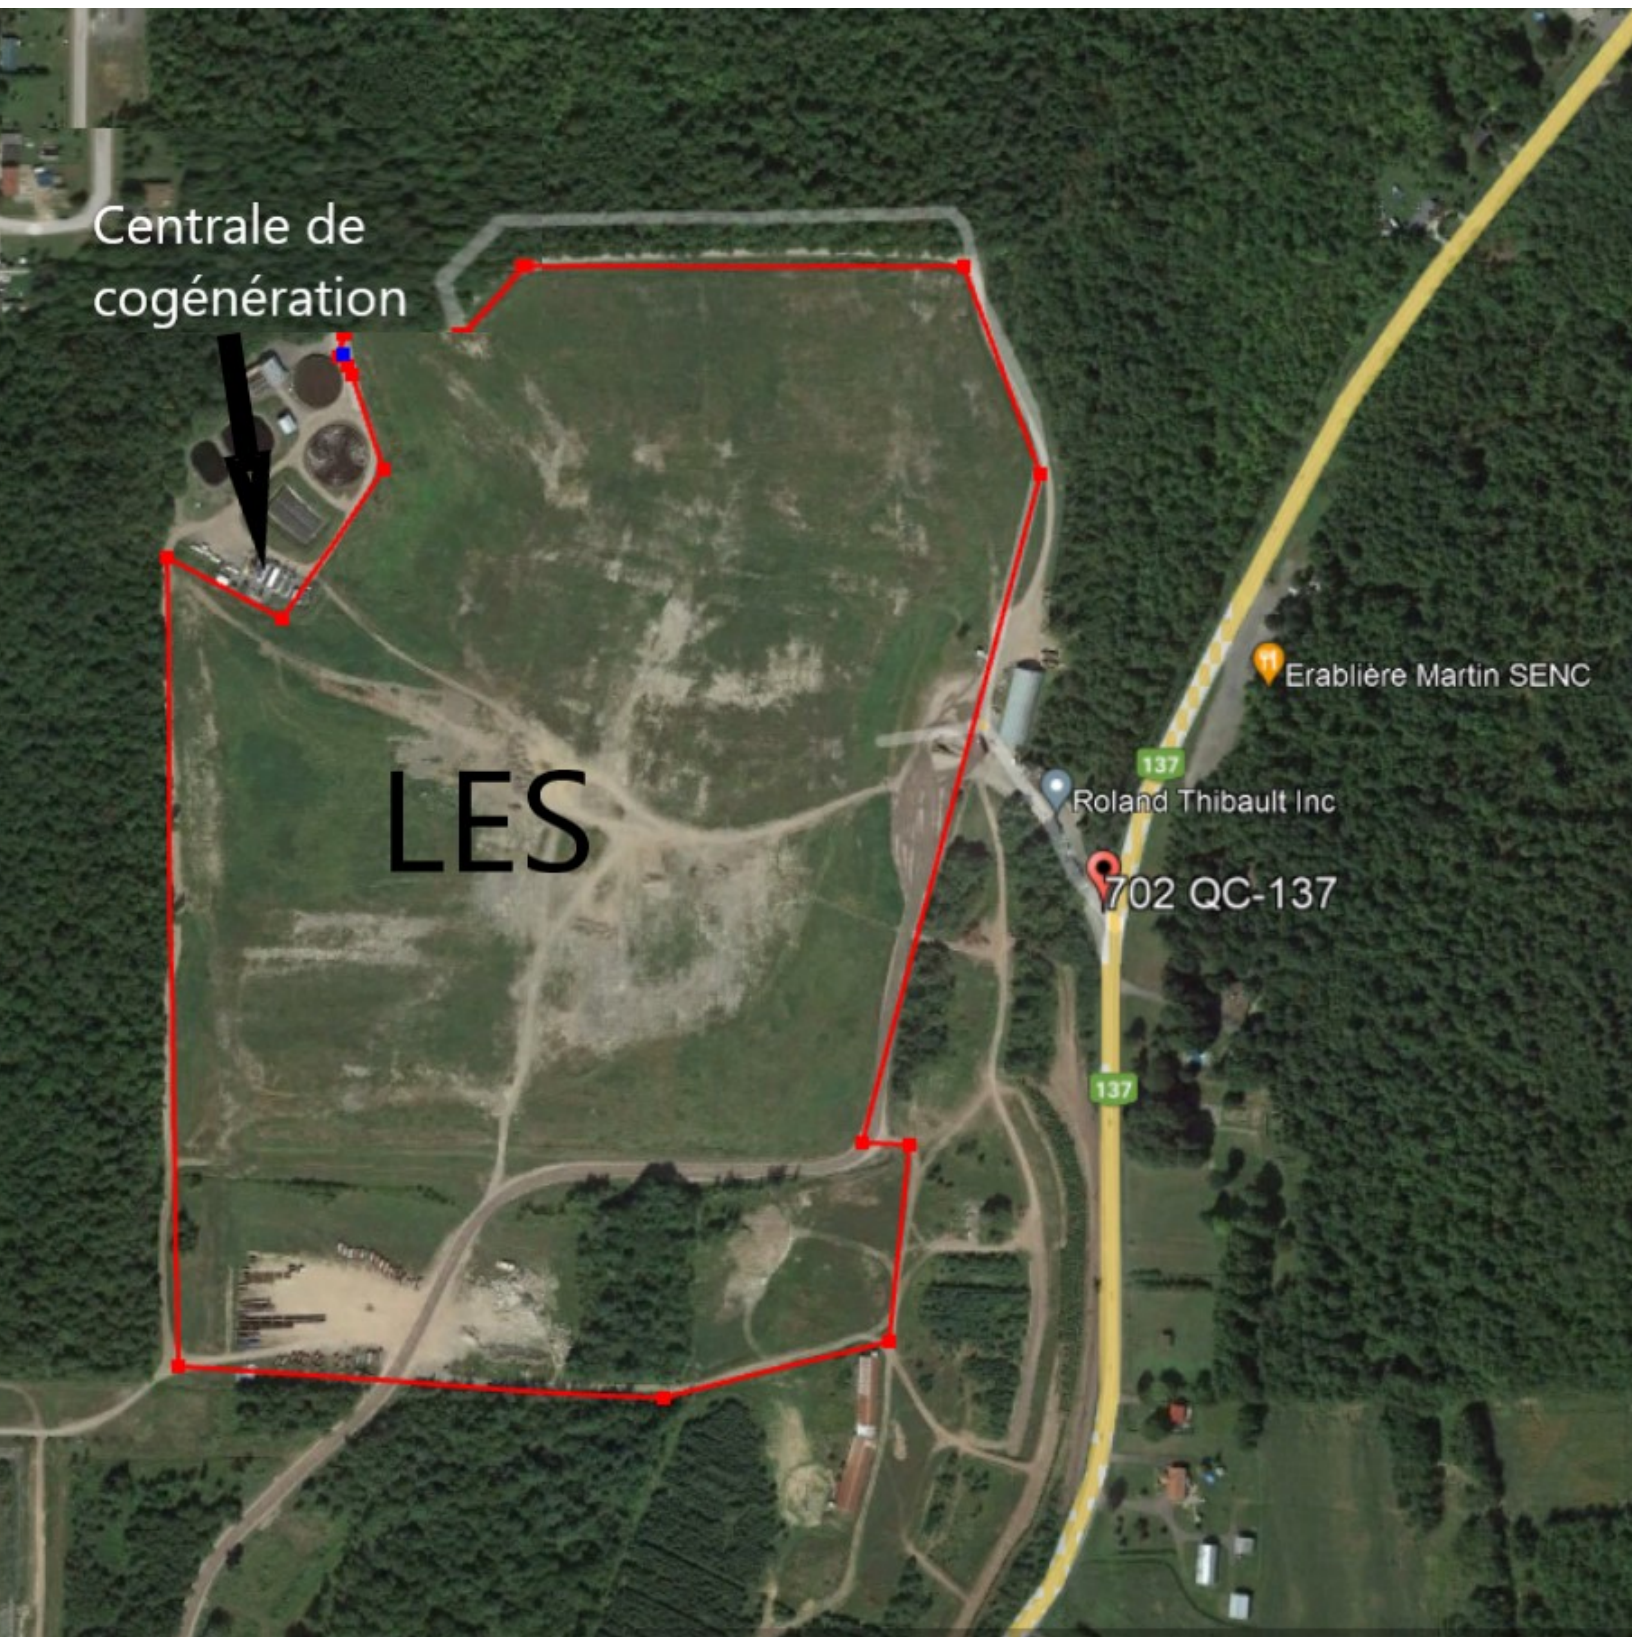
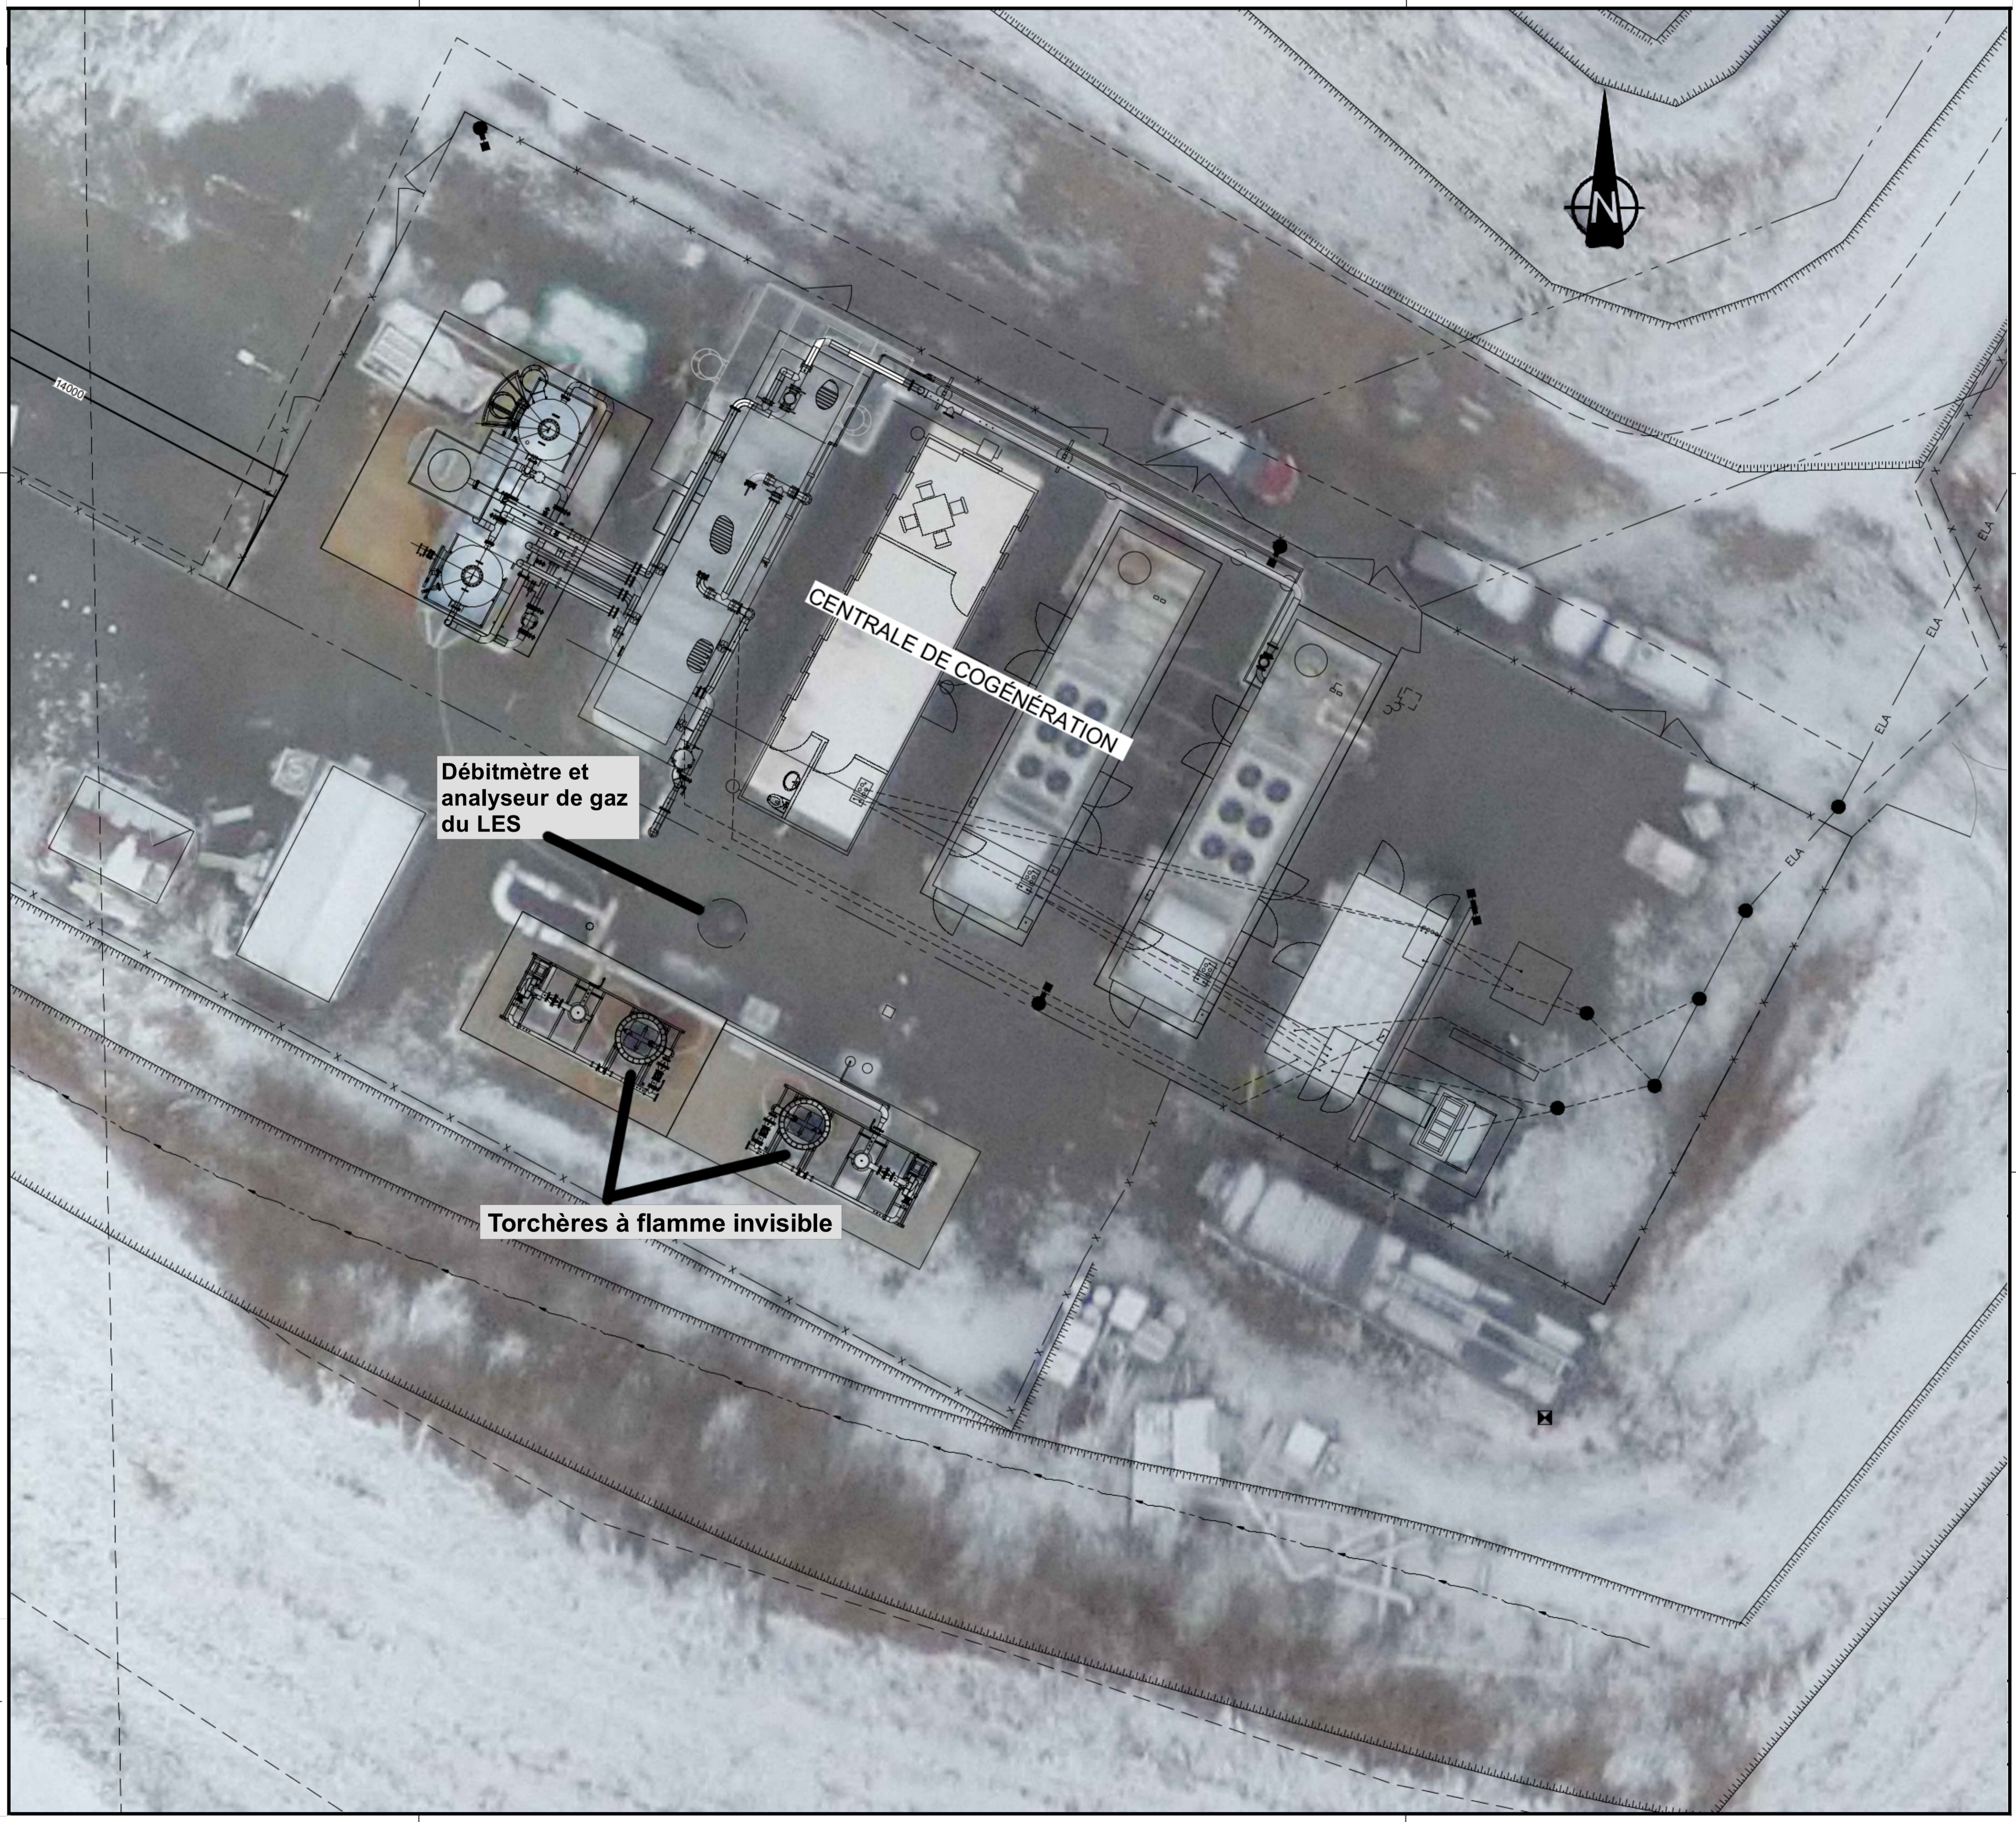
**Débitmètre et
analyseur de gaz
du LES**

Torchères à flamme invisible

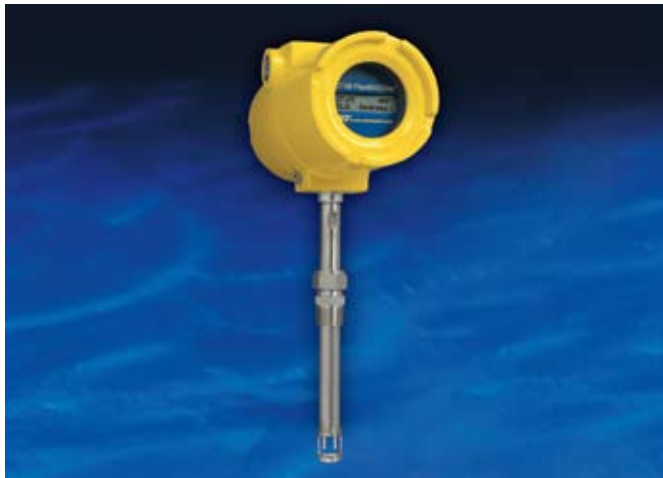
Model ST98 is an insertion flow meter for pipe sizes from 2 1/2" to 42" [64 to 1066 mm]. Typical calibration range is from 0.75 to 600 SFPS [0.21 to 172 NMPS].¹

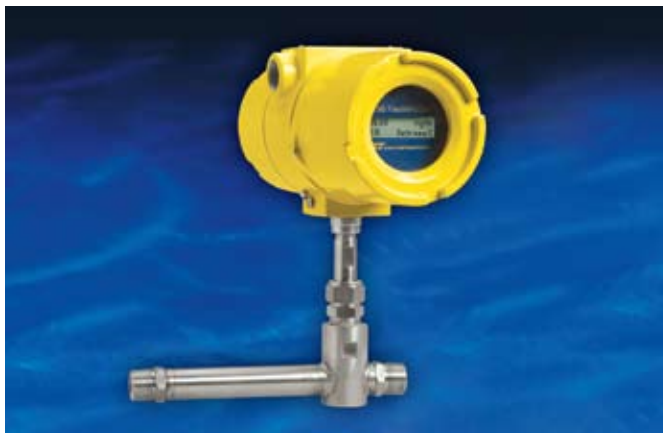
Model ST98L is an in-line flow meter for use in line sizes 1", 1 1/2" and 2" [DN25, DN40, and DN50]. Typical calibration range is from 0.006 SCFM to 1850 SCFM [0.01 NCMH to 3140 NCMH].¹

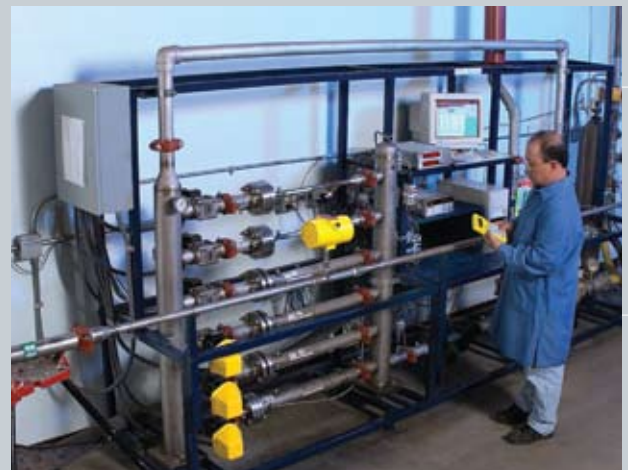
More than 16 precision flow stands to match fluids, process conditions, flow rates and line sizes specified in your application.

For most gases, FCI ST98 thermal dispersion flow meters are calibrated using the actual gas as well as the actual temperature and process conditions matching your application. Other suppliers are limited to air calibration with un-validated theoretical equivalencies for gases. FCI has demonstrated this procedure to be inferior and subject to installed errors well outside published specifications. For most other suppliers to perform actual gas calibrations equal to FCI, their flow meter must be sent to an outside laboratory resulting in extra costs and shipping delays to you.
